PUMP REPAIR AND EFFICIENCY ENHANCEMENT WITH BELZONA

Drinking Water Supplier, Portugal

Large horizontal split case pump housing

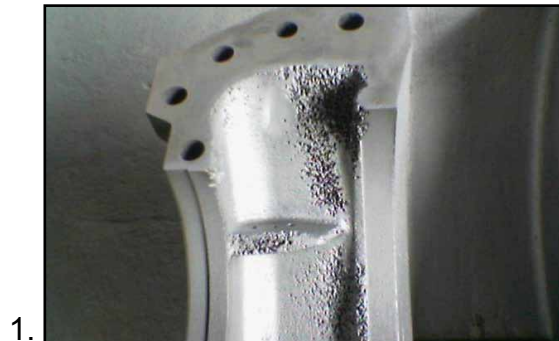
The pump had significant corrosion.

1. The severe localised corrosion
2. Application of Belzona® 1111
3. The completed repair
