END SUCTION PUMP REPAIRS WITH BELZONA

Sugar beet plant, Portugal

Several large end suction pumps used in processing of sugar beet.

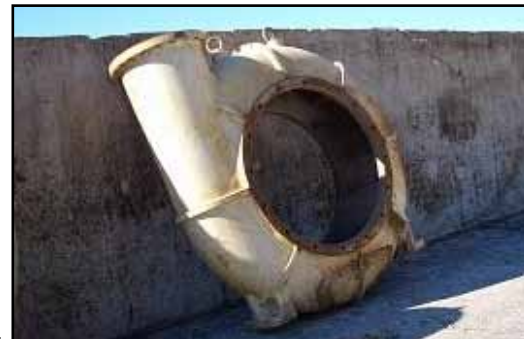
The pumps had suffered severe erosion and significant corrosion caused by solids entrainment.

1. Pump housing
2. End covers with erosion clearly evident
3. The components restored to original dimensions
