## BELZONA PROVIDES GREAT RETURN ON INVESTMENT

Air handler shaft

Worn shaft caused air handler to not operate effectively.

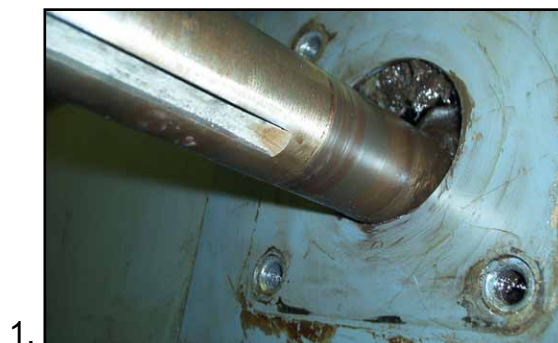
1. Worn area of air handler shaft
2. Surface preparation in-situ
3. Cured Belzona® 1111
4. Air handler back in service
