BELZONA SEALS HOLED HEAT EXCHANGER

Coal-fired Power Plant - Macedonia

Heat exchanger operating at 90 °C

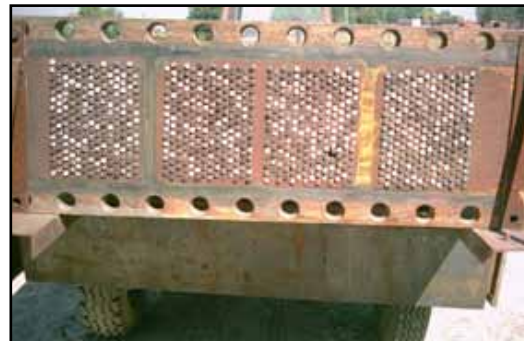
1. Preparing the heat exchanger for blasting
2. The hole in the tube sheet is evident
3. The hole is filled with Belzona® 1311
4. The heat exchanger surface coated with Belzona® 1591

Application was carried out in accordance with Belzona Know-How System Leaflets HEX-1 and HEX-3.

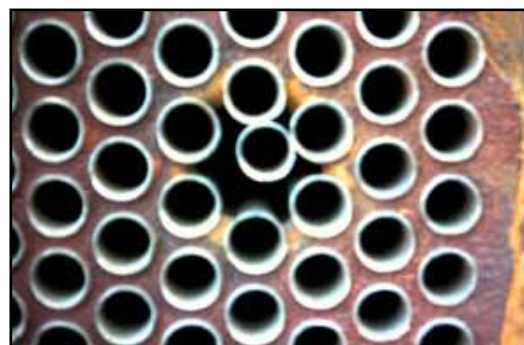
2.

Hole in a tube sheet due to erosion and galvanic corrosion between copper tubes and steel tube sheet.
