## AGITATOR SHAFTS CURED WITH BELZONA

Oil Processing Facility, Liverpool, UK

7 diameter mild steel agitator shaft"

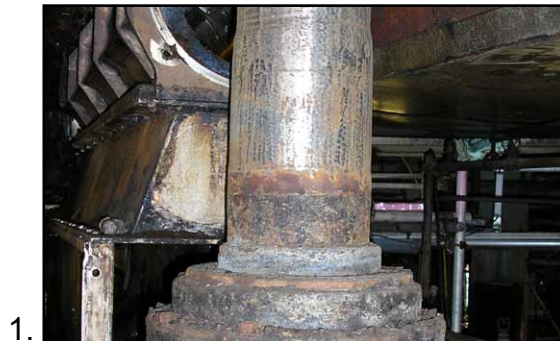
The main shaft on the agitator had worn down under the stuffing box over a number of years by up to 2 overall on the diameter over 21" of the shaft length."

1. The shaft in situ showing the extent of the damage
2. The former ready to be applied
3. The former in place after application of the material
4. The finished shaft with only a small split line requiring dressing
