BELZONA PUMP RESTORATION

Water Plant, Egypt

Four split casing pumps

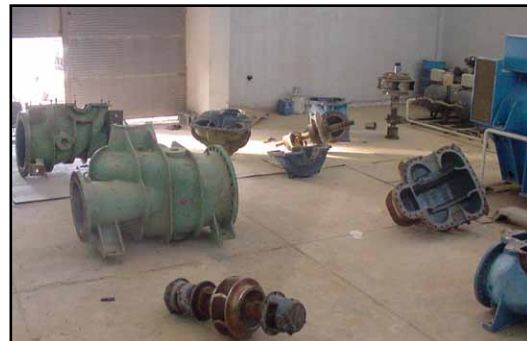
The four pumps were very badly eroded and corroded. As a result, the flow rate was much lower than the normal flow rate.

1. General view of the four deteriorated pumps
2. Corroded-eroded pump and cut water
3. Rebuilding the eroded areas inside the pump
4. Completed application

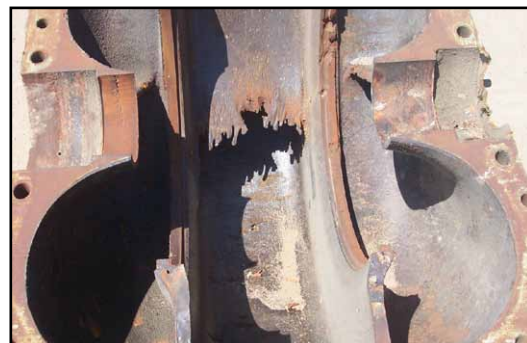
2.

Each of the four pumps was facing many problems in the cutwater and the wear ring seats which decreased the efficiency of the plant. Instead of buying new pumps Belzona was used to repair the old pumps providing extra protection while restoring the plants power without resorting to buying new expensive units.
