BELZONA REPAIR TO GAS BREAKER

Electrical utility in Oklahoma

Aluminum gas breaker at substation outside natural gas powerplant

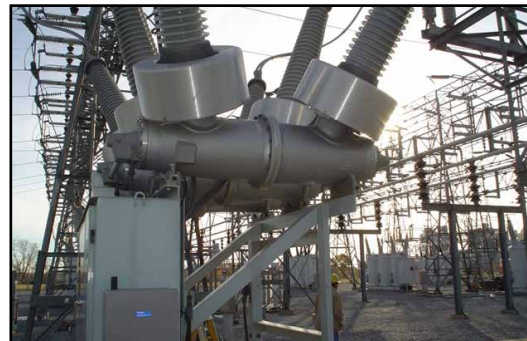
Gas was quickly escaping and the utility had to send maintenance crews to refill the breaker every 2 weeks so that it would not lock-out.

1. The breaker leaking gas
2. Soapy water sprayed to detect location of leak
3. Area prepared for application by grinding
4. Completed repair soaked in soapy water to ensure no leaks
