BELZONA RECLAIMS DAMAGED BOWLING ALLEY SIDEPLATE

Bowling Centre, Calgary, Alberta, Canada

Damaged side plate on the pin deck

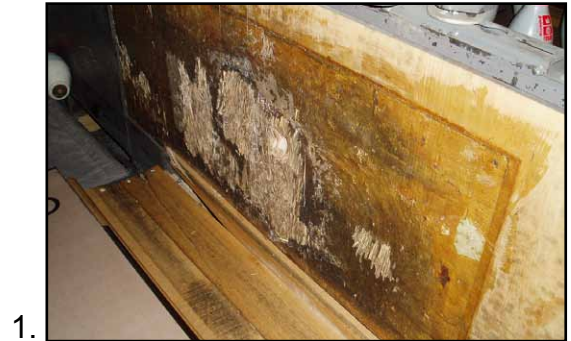
1. Damaged hardwood slab, 3/4-inch deep
2. First layer of Belzona® 8111 applied
3. Final layer of Belzona® 8111 after sanding
4. Kick plate reinstalled over damaged area

The method used was similar to rebuilding pitting corrosion on vertical vessel walls, a modified Belzona Know-How System Leaflet TCC-5.
