BELZONA STOPS THAT SINKING FEELING

Sand Pit Wichita, Kansas

Floating sand dredger

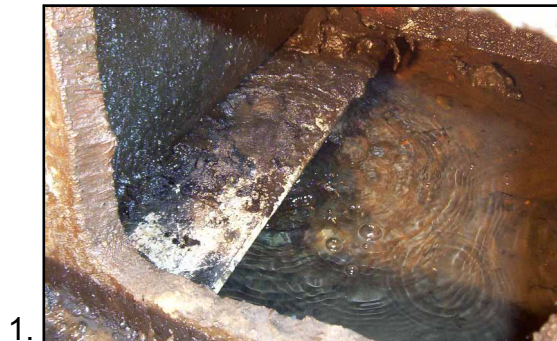
The hull was leaking in several areas of this sand dredge. If the electricity failed when the plant was unattended the vessel could sink into 30 feet of water.

1. Leak in the hull
2. Cutting magnetic sign material
3. Divers positioning signs to stem the leak
4. Leak stopped with Belzona® 1111
