BELZONA BUND SEALING TO ENSURE ENVIRONMENTAL COMPLIANCE

Commercial Vehicle Repair Shop

Bund floor and walls

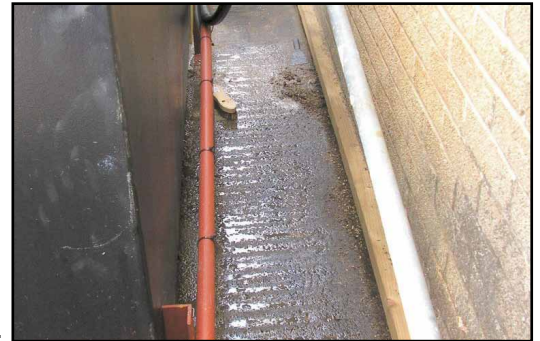
Legislation non-compliance due to newly constructed bund being porous due to construction materials, concrete base and 9 inch concrete block walls.

1. Porous bund floor and side wall
2. Introduction of wall to wall fillets
3. Wall penetrations sealed and fillet complete
4. Finished job
