BELZONA MAINTAINS CHIPPER DISC POCKET PROFILE

Papermill in California U.S.A.

Deterioration of vertical flywheel-type chipper disc pocket profile.

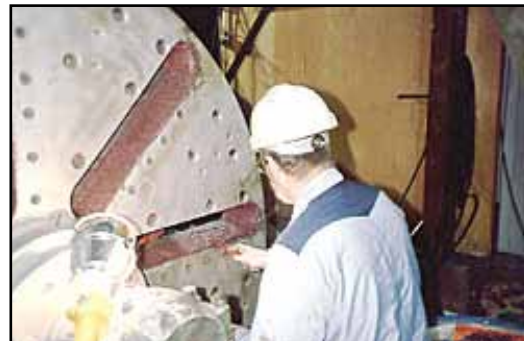
1. Knife removal from the disc
2. Damage to the pocket profile
3. Applying Belzona® 1811

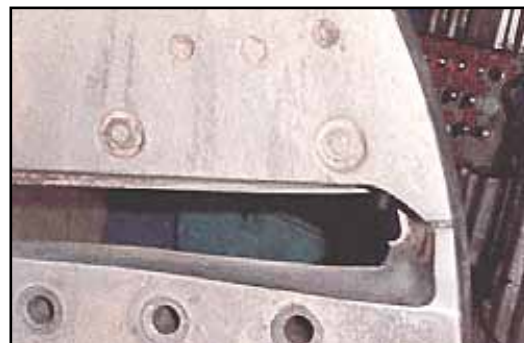
2.

The chipper disc pockets exhibit wear and require constant maintenance. Off-size chips adversely affect the pulping process and the quality of the resultant paper.
