BELZONA EXTENDS THE LIFE OF THIS SCREW PRESS

Paper mill in Wisconsin, U.S.A.

Shaft wall thickness of an Andritz Screw Press.

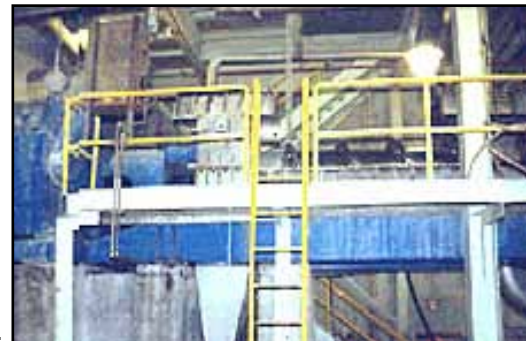
The Andritz Screw Press is used to remove water and thicken the pulp stock. The screw shaft on this machine lost nearly half of its 7/8" wall thickness due to abrasion from the fiber as it is pressed against the screw.

1. Overall view of the Andritz screw press
2. Surface preparation by grit blasting
3. Finished application
4. After 6 months of operation

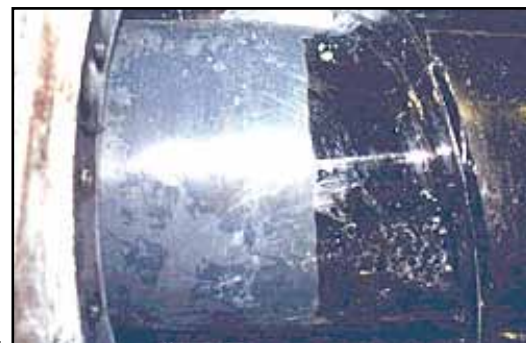
4.

The shaft had previously been resurfaced by welding at a cost of \$12,000, but only lasted 18-months. The manufacturer recommends that the screw only be welded once and then replaced at a cost of \$80,000. After 6 months of service, over 75% of the top 0.040" layer of Belzona was still intact
