BELZONA FOR THE REPAIR OF STEP NOSINGS

Furniture manufacturer in North Carolina U.S.A.

Steps at a furniture manufacturing facility leading to a loading area.

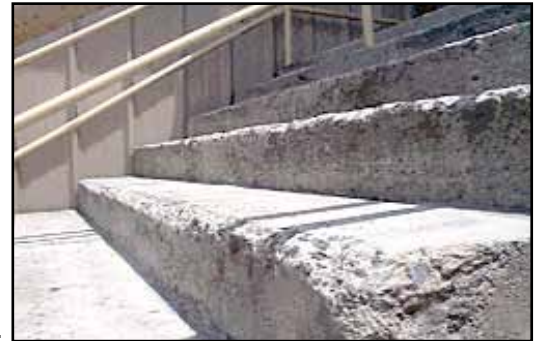
The step nosings leading to a loading area became rounded from constant traffic and improper handtruck usage.

1. Damage to step nosings
2. Belzona® 4911 (TX Conditioner) applied to steps
3. Peeling tape off to reveal Belzona® 4411
4. Completed application
