BELZONA KEEPS ENTRANCE WAY STEPS LOOKING GOOD AND SAFE

Agency building - Houston, Texas U.S.A.

Step nosings along a very visible entrance way.

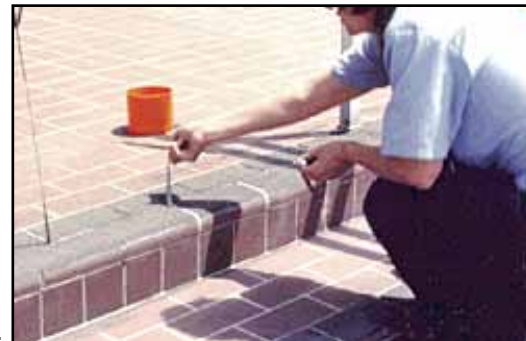
1. Pulling the tape while the Belzona® 4411 is still wet
2. View of entire area
3. Close-up view of completed application

Belzona® 4411 was applied by brush in conjunction with Belzona® 9221 on the nosings of the quarry tile steps. 1/4 inch tape was cut and placed over the grout lines of the tile to simulate the quarry tile appearance. This area is high visibility for visiting dignitaries and tourists, so emphasis was placed on safety and cosmetics.
