## BELZONA TAKES OFF AT THIS INTERNATIONAL AIRPORT

International Airport, U.S.A.

Landing areas and ramps.

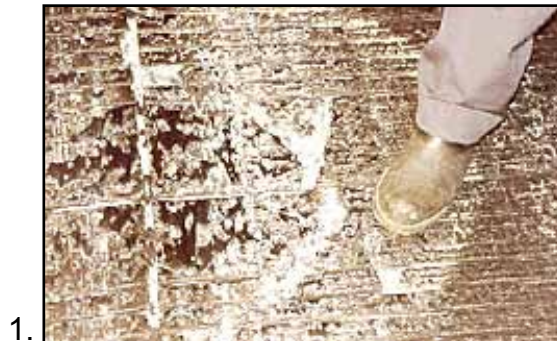
Certain sections of the runway and ramps were spalled from both thermal cycling as well as mechanical damage from constant aircraft traffic.

1. Spalled concrete on runway
2. Surface prepared by chipping loose concrete
3. Conditioned with Belzona® 4911 (Magma TX Conditioner)
4. Curing of completed repair being accelerated with heat
