BELZONA HEALS HOSPITAL EXPANSION JOINTS

Hospital in North Carolina, U.S.A.

Deteriorated expansion joints throughout hospital hallways.

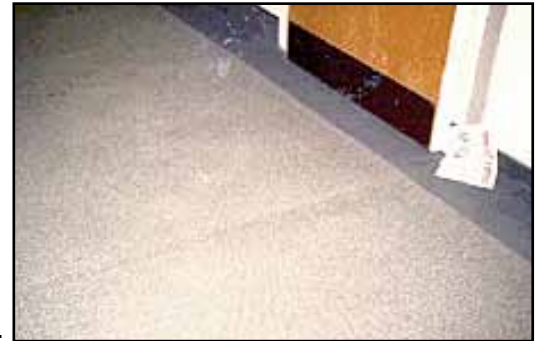
Deteriorated expansion joints cause problems with x-ray equipment as well as with individuals tripping throughout the hallways.

1. Joint indentation evident through carpet
2. Concrete nosings spalled from traffic
3. Nosing rebuilt and joint sealed
4. Completed application ready for traffic
