BELZONA KEEPS WATER SAFE TO DRINK

Regional Water Authority in England

Underground concrete water storage tank.

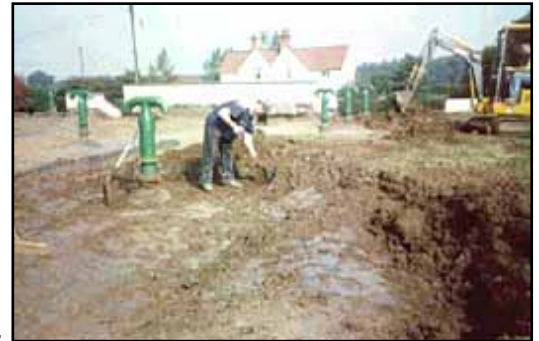
1. Excavating underground storage tank
2. Crack through roof of tank
3. Repaired with Belzona® 4111

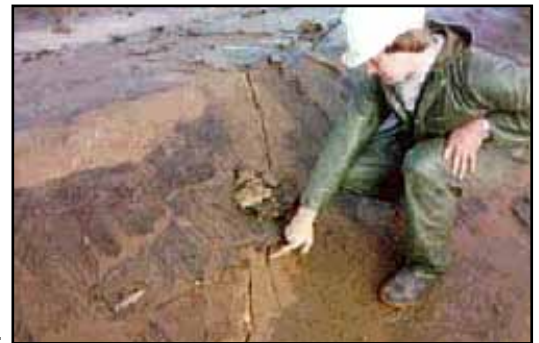
2.

Cracks in the roof of the storage tank were allowing the ingress of surface water and contaminating the potable water contained in the reservoir. This leads to unacceptably high levels of nitrate, phosphate and miscellaneous contaminants in the tank.
