STRIPPED LUG REPAIRED WITH BELZONA

Stripped threads in casing lug of a 50cc Honda Moped.

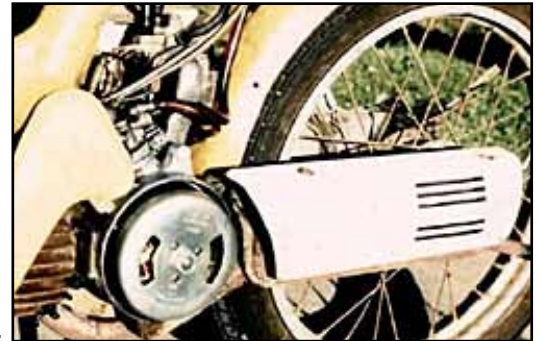
Improper installation of a casing lug for this 50cc Honda Moped stripped the aluminum housing and was unable to seal the casing properly.

1. View of cycle
2. Bolt being held in centralized position
3. Completed repair

Belzona® 9411 (Release Agent) was applied to the casing bolt and allowed to dry for 20-minutes. The existing thread profile was roughened and thoroughly degreased. Belzona® 1111 was then applied to both surfaces and then both were introduced in the lug and centralized. Following full cure, the Belzona thread is still operating successfully after many years.
