BELZONA REPAIRS THIS VACUUM PUMP AND INCREASES ITS EFFICIENCY

Fossil fuel power station in Australia

Water ring vacuum pump for main condenser.

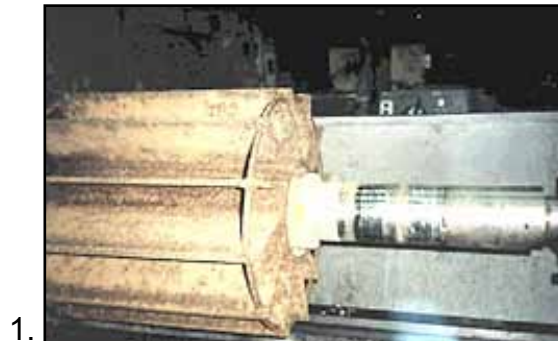
Corrosion damage to the end covers and impeller, as well as heavy souring of the gland packing locations on the impeller shaft caused insufficient vacuum pumping and loss of pressure.

1. Scored area of the shaft
2. Undercoat area of the damaged shaft
3. Application of Belzona® 1131
4. The rebuilt shaft after machining of Belzona® 1131
