BELZONA STAVES OFF REPLACEMENT COST ASSOCIATED WITH THIS CHIPPER

Lumber Company in California USA

Klockner Rotary Chipper knife pocket wear.

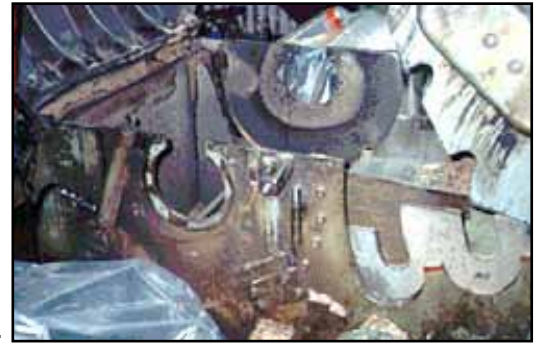
1. View of the Klockner Chipper apparatus
2. Rotor assembly with worn pockets
3. Knives removed from unit
4. Applying Belzona® 1811 to pocket profile

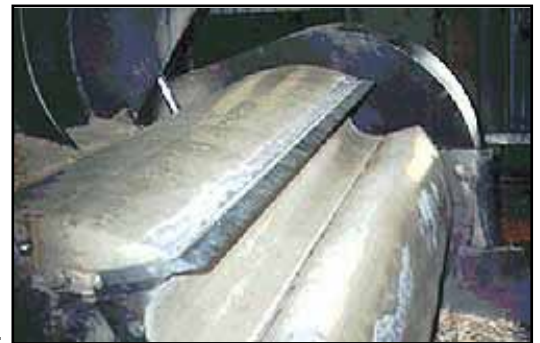
This unique chipper from Germany has 48" knives that are responsible for cutting the lumber into the appropriate chip size. Over a period of time, the knife pockets wear, causing unwanted fines and off-size chips.
