BELZONA RECLAIMS A SHAFT AFTER A BEARING FAILURE DAMAGED BOTH ENDS

Abitibi Price Paper Mill in Ontario, Canada

Both bearing surfaces of an embossing roller shaft.

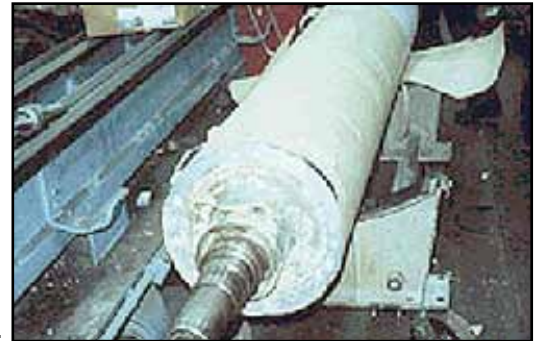
A hydraulic press on either end of an embossing roller is used to control appropriate operating pressure, caused premature bearing failure, damaging both ends of the shaft.

1. Scored shaft of an embossing roller
2. Application of Belzona® 1111
3. Accelerating the cure using a heat gun
4. Rebuilt bearing surface and shoulder using lathe
