BELZONA GETS HEAVY EQUIPMENT BACK IN SERVICE, FAST!

Scored hydraulic ram for a front end loader.

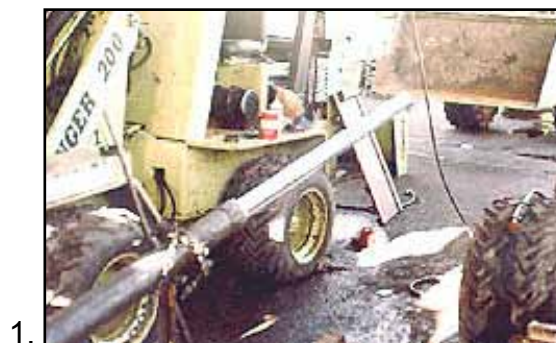
Small pieces of rock worked their way underneath the seal and scored the hydraulic ram of this front end loader. Since hydraulic pressure was not able to be maintained, this piece of equipment was out of service.

1. Damaged hydraulic ram
2. Close-up and extension of cylinder damage
3. Surface preparation with small grinder
4. Dressing down the repair
