BELZONA RESTORES BEARING HOUSING TO LIKE-NEW CONDITION

Paper Mill in Japan

A bearing housing from the winder section of a paper machine used to support and provide tension to the reels of paper.

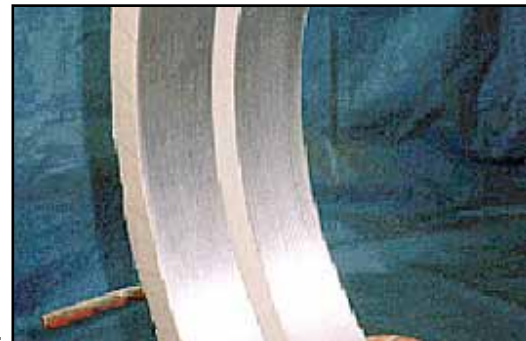
1. Surface preparation of bearing housing
2. View of damaged flange mounting
3. The bearing housing is ready for service

The application was carried out in accordance with Belzona Know-How System Leaflet MPT-6. Applied by hand and machined to tolerances.

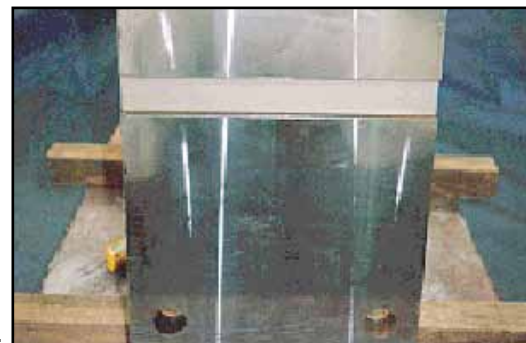
2.

This winder bearing housing suffered mechanical damage from vibration, foreign substances and irregular rotational motion.

Belzona® 1111 was machined to form a perfect cylindrical bearing surface while maintaining the lubrication seal. The flange mounting was also rebuilt and machined for a secure mating surface to the paper machine framework. The winder section of the paper machine must run continuously and reliably in order for the mill to remain profitable.
