BELZONA RESTORES THE PROPER SURFACE PROFILE TO A PRESS ROLL

Paper Mill in Minnesota, USA

Press roll surface profile.

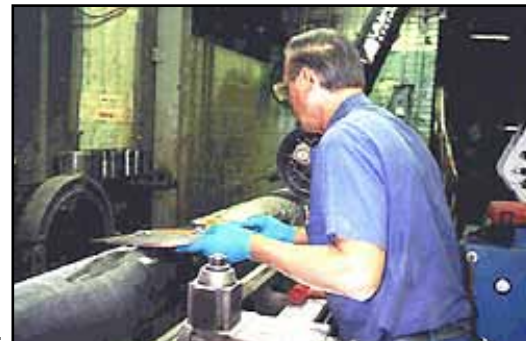
1. Applying Belzona® 1111 to damaged press roll
2. Removing excess Belzona from repair area
3. Machining repair to tolerances
4. Final rectification to maintain proper surface finish.

Belzona® 1111 (Super Metal) was used to repair the damaged surface of the press roll after a metal bolt had gone through the machine. The roll was then unable to remove water from the paper. This produced poor quality paper and resulted in breaks.
