BELZONA PROVIDES LONG TERM PROTECTION FOR THIS TROUGH

City of Boone Wastewater Treatment Facility, North Carolina, USA

Concrete clarifier trough

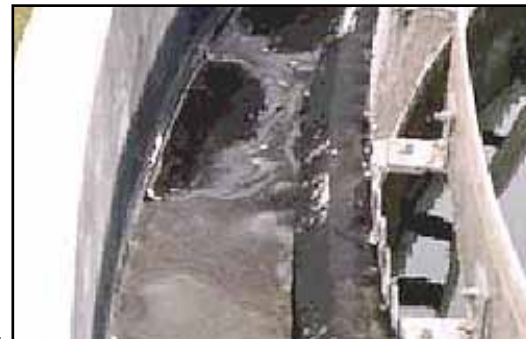
Previous elastomeric coating started to fail and algae built up and made it very difficult to clean. In addition, the concrete behind the lining began to deteriorate, as cracking and spalling of the substrate were evident.

1. Previously damaged elastomeric lining
2. Clarifier trough rebuilt with Belzona® 4131
3. Clarifier trough coated with Belzona® 5811
4. Clarifier back in service.
