BELZONA REPAIRS AND ENHANCES CONCRETE CLARIFIER TROUGHS

Wastewater treatment plant in Plantation, Florida USA

80-ft diameter concrete clarifier trough.

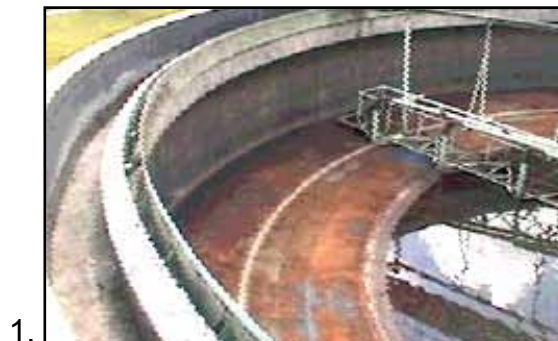
1. Clarifier drained to affect repairs
2. Concrete damage from failure of coal tar epoxy system
3. Application of second coat of Belzona® 5811
4. Finished application.

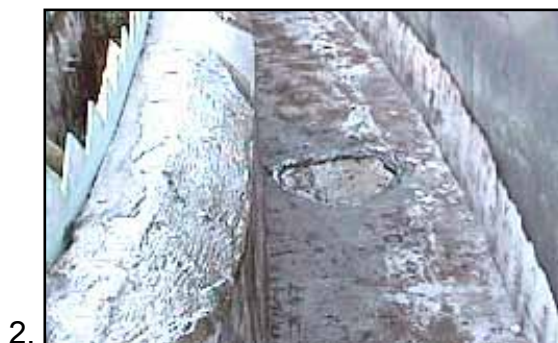
An old coal tar epoxy system had failed and resulted in damage to the underlying concrete. It also made it very difficult to keep the trough clean and free from algae buildup.
