WORN FAN BLADES RESTORED WITH BELZONA

Power station in Thailand

GRP fan blades from cooling towers.

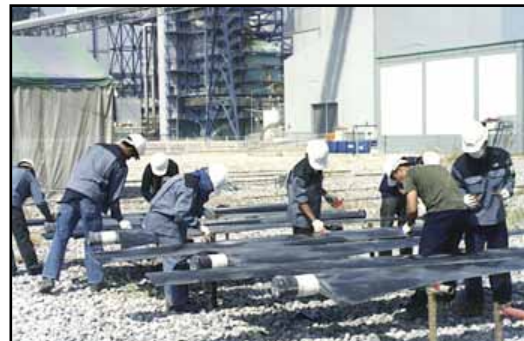
1. Application of Belzona® 4151 to the blades
2. Belzona® 1341 applied to leading edges
3. Belzona® 5111 applied by airless spray
4. Blades being returned for installation to cooling towers

Belzona® 4151 was used to repair the damaged top coat on the blades. Belzona® 1341 was used to protect the leading edges and Belzona® 5111 was used to provide overall protection. The Belzona refurbishment has avoided the high cost of blade replacement and provided the plant with long term protection of the blades.
