BELZONA STOPS LEAKING IN CONCRETE JOINTS

Elevated water supply tower.

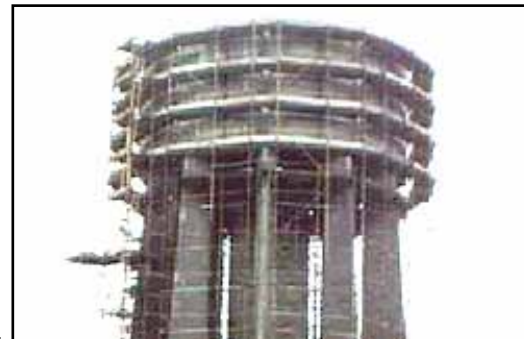
1. Water tower with access scaffolding in place
2. Typical leaking and staining
3. Completed application after second coat of Belzona® 4211

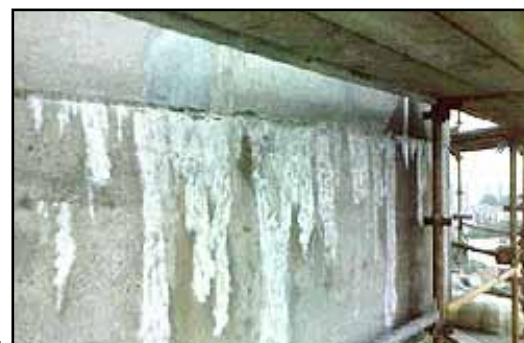
2.

Water seepage was occurring at many of the joints in the cast concrete structure.

Joints were cleaned out thoroughly and Belzona® 4211 was used to seal obvious live leaks. Joints were then treated with two coats of Belzona® 4221 overlapping onto the surrounding concrete by approximately 12. Application was completed with no interruptions to water supply."
