BELZONA RESTORES POTABLE WATER SUPPLY TO CHINESE CITY

Municipal concrete water pipeline in Guang Dong Province, China

Damaged to concrete water pipeline.

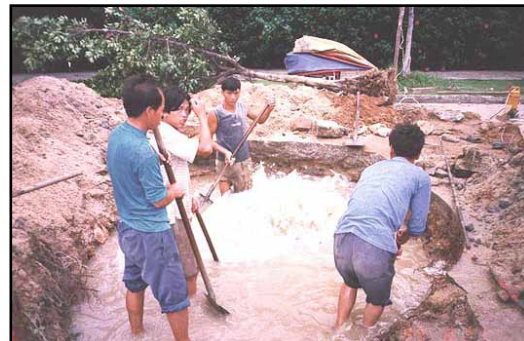
Routine construction above caused physical damage to this 1.2 meter diameter concrete pipeline carrying potable water to Guang Dong Province.

1. Pipe leaking large volumes of potable water
2. Pipe damage prepared for Belzona repair
3. Repair completed with Belzona® 4111
