BELZONA PERMANENTLY SECURES HANDRAIL POSTS

Municipal sewage treatment facility in Minnesota, USA

Spalled concrete around handrail posts at a sewage treatment plant.

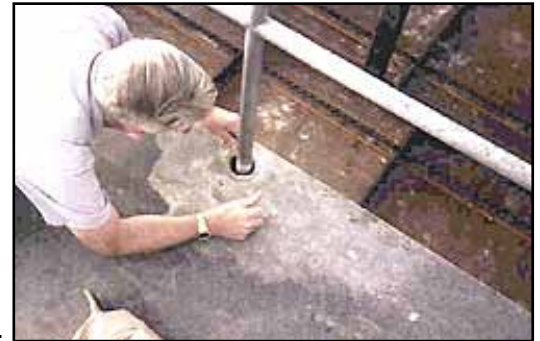
Liquid was pooling around these handrails, spalling the concrete and loosening the rails at this municipal sewage plant to such an extent that worker safety was in question.

1. Removing loose debris from the handrail post/concrete interface
2. Injecting Belzona® 4151 into the handrail post hole
3. Filling in the irregularity with the aggregate
4. Finished repair by mounding the resin to the shed water
