PIPING DISTRIBUTION HEADER REPAIRED WITH BELZONA

Water treatment plant in Florida, USA

Sludge water piping distribution header.

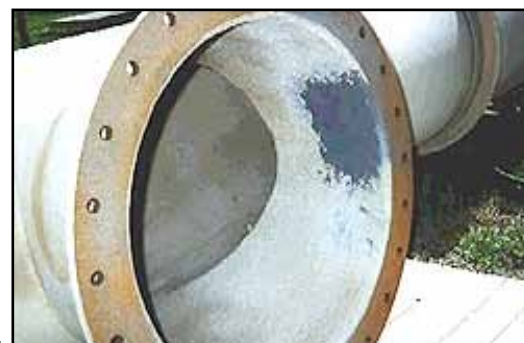
Corrosion as well as erosion deteriorated the entire internal surface of this sludge water piping structure. This pipework transports sludge water from the sedimentation tanks to the digester.

1. View of the sedimentation tanks
2. Repairs to pits with Belzona® 1111
3. First coat Belzona® 5811
4. Second coat of Belzona® 5811 almost complete

Belzona® 1111 (Super Metal)
