BELZONA'S ABS APPROVED PROCEDURE USED TO REPAIR PROPELLER BOLT HOLES

MSTS (Military Sealift Command) in Florida, USA

Bolt holes in propeller.

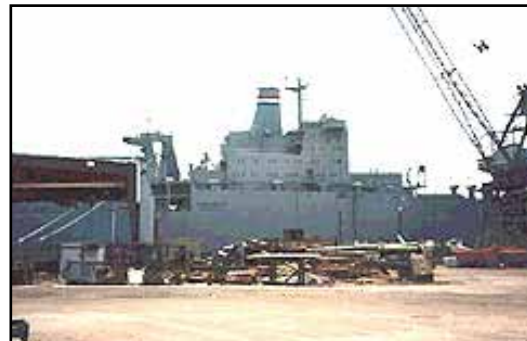
1. View of military sealift command vessel
2. View of the ships propeller
3. Applying Belzona® 1111 to the bolt holes
4. Finished applications being cured

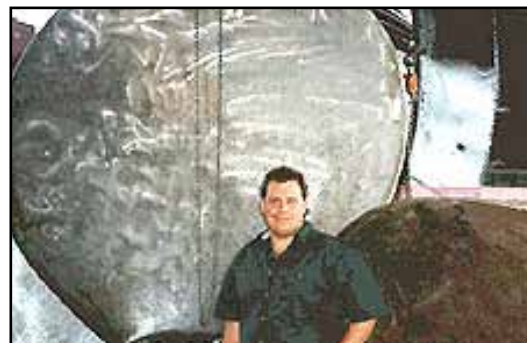
2.

Excessive pitting on the propeller was due to a combination of crevice corrosion and general corrosion caused vibration and uneven distribution of load.
