BELZONA KEEPS THIS PASSENGER FERRY RUNNING SMOOTHLY

Rudder horn of large ferry vessel.

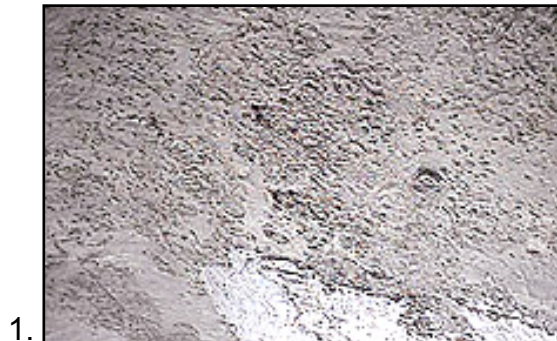
The sides and trailing surfaces of this large rudder horn suffered from cavitation and significant metal loss.

1. Cavitation clearly evident
2. Rebuilding with Belzona® 1121
3. Belzona® 2141 being applied
4. Final application
