## BELZONA CORRECTS OVERSIZED KEYWAY

Paper Mill in Washington State U.S.A.

Mechanical keyway used to control residence time of the decker lumber.

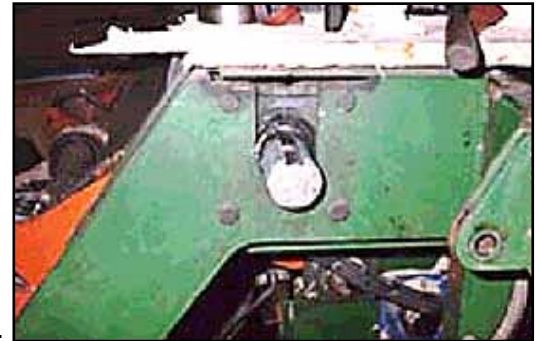
This lumber decker keyway takes a tremendous beating because of cyclic loading. Because of the start-stop characteristics, the keyway housing became oversized.

1. The equipment prior to the application
2. The keyway has been repaired
3. The material has cured and the equipment is ready for service
