BELZONA SEALS CRACKS IN UNDERWATER CONCRETE TANK

California water plant, U.S.A.

Concrete cracks in base of aquaduct.

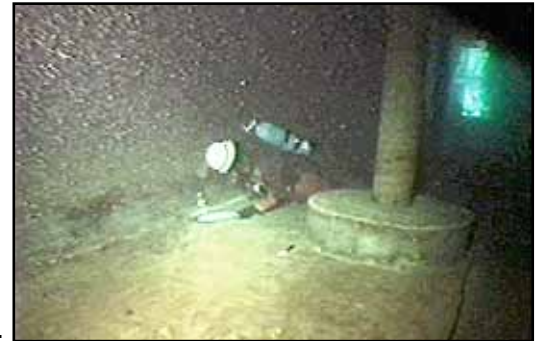
1. Diver sent down to begin the application
2. Diver utilizing a putty knife to force Belzona[®] 4111 into concrete cracks
3. Large section of spalled concrete repaired

The aquaduct could not be drained so the only alternative was to do an underwater application. The slurry version of the Belzona[®] 4111 can easily wet out the concrete and even though adhesion is reduced, the repair was still a success.
