## BELZONA PROVIDES EROSION/ CORROSION PROTECTION TO THIS POTABLE WATER TANK

Potable water holding tank at power plant.

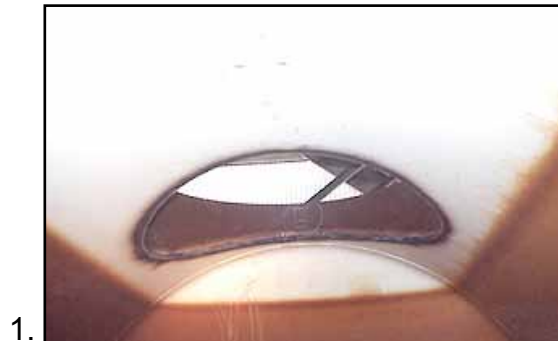
Erosion-corrosion and blistering of original coating.

The original tank coating failed after three years as a result of cold wall blistering. Belzona® 1341 NSF was used for erosion/corrosion protection. The product is certified to ANSI/NSF Standard 61 as acceptable for use in contact with drinking water.

1. Internal view of the tank with corrosion evident
2. First coat of Belzona® 1341
3. Application of Belzona® 1341 complete
4. Outside of tank coated with Belzona® 6111 and Belzona® 5111
