## BELZONA REPAIRS AND PROTECTS AUTO REPAIR SHOP FLOOR

Auto Repair Center in Northern Florida - U.S.A.

Parts & Battery Storage Area

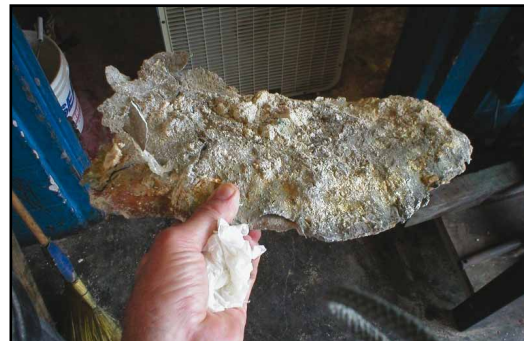
Floor area damaged due to exposure to sulfuric acid.

1. Prior to application
2. Prepared floor
3. Belzona® 4131 (Magma-Screed) and Belzona® 5811 applied to protect application area long term
