## BELZONA® 4000 SERIES FLOOR COATING FOR A STERILIZING ROOM

Medical Sanitizers - Minnesota U.S.A.

March 2002

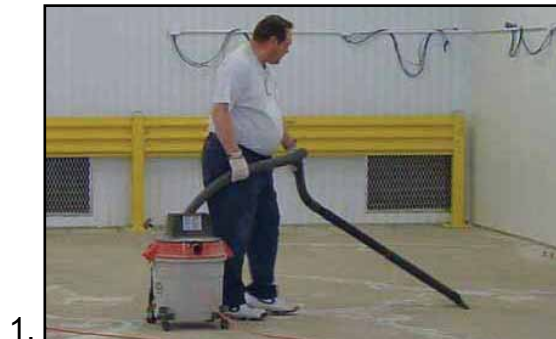
1. Final steps of surface preparation
2. In progress
3. Job complete

The application was carried out in accordance with a modified version of Belzona Know-How System Leaflet FPA-3. Shot-blasted floor, followed by thorough cleaning. Roller/brush application of product in a slurry-grade.
