BELZONA PROTECTION TO BUTANE TANK BASE

International Petroleum Company - Australia

Insulated tank containing Butane at -6°C (21°F).

Corrosion at base of tank. At same time, timber supports were being renewed.

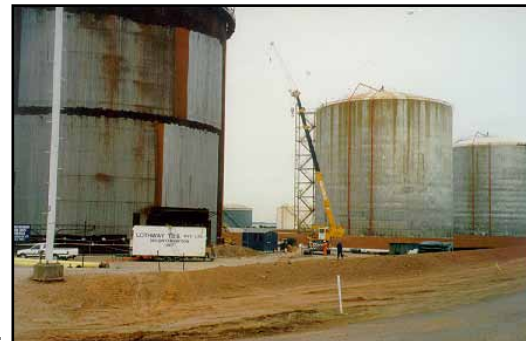
1. General view of the tank
2. Preparation of tank and base underway. Tank jacked up ready to install new timbers
3. Application underway
4. Application being completed
