BELZONA REPAIRS 24" PIPE ELBOW

Petrochemical Plant, Kuwait

24" Diameter pipe used to carry seawater

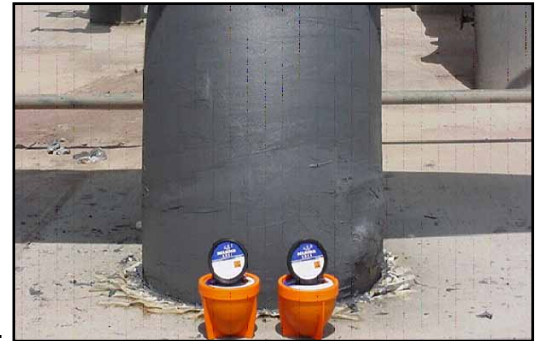
Failure of the internal lining had lead to wall thinning and a through wall defect. NDT was used to define the thinned area.

1. Front view
2. Side view
3. Test piece being prepared for evaluation

A steel patch was welded into position in the area of the through wall defect. A base layer of Belzona® 1311 was applied followed by Belzona® 9341. The whole process was then repeated and a layer of Belzona® 1311 applied to give a smooth finish.

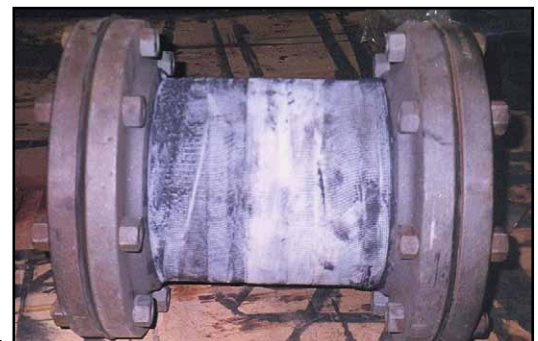
3.

This repair was evaluated extensively by the maintenance team prior to being undertaken. Defects were ground into pipespools and the pipespools were then wrapped in the manner described above. These were then successfully pressure tested prior to undertaking the actual repairs.
