BELZONA PROTECTS OPEN DRAINS TANK

North Sea gas producer

2003

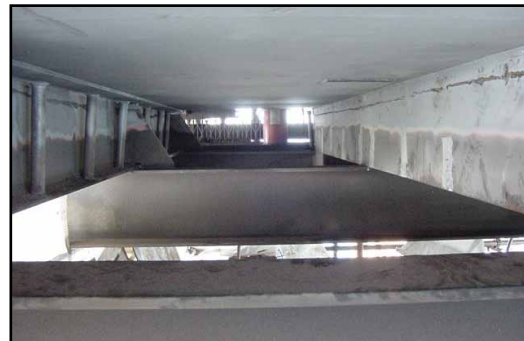
1. Front view showing Belzona product
2. Side view
3. Sealing of tank base seams using Belzona® 1111

The tank base was grit blasted and plates were secured in position using Belzona® 1111 and held in place using chocks. Once the Belzona® 1111 had been allowed to cure, Belzona® 5811 was injected into the gap between the plate and the tank base. In addition all of the tank nozzles were wrapped using Belzona® 1111 / 9341 along with all of the tank base weld seams from the tank side/base joint. Following this the new tank base and sides were coated with Belzona® 6111 / 5111 for future corrosion protection.
