SLOPED SURFACE MADE SAFE WITH BELZONA

Commercial Business Park in Albuquerque, New Mexico U.S.A.

Walkway entrance to office building.

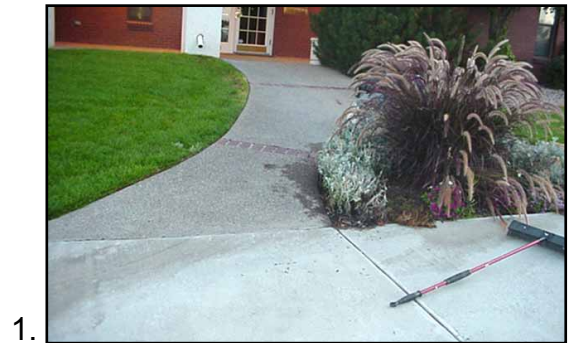
Sloped walkway with exposed aggregate became very slippery when wet, creating a safety hazard.

1. The slope walkway entrance was very slippery when wet.
2. The pattern is created as tape is being laid.
3. Application of the Belzona® Non-Slip System in progress.
4. The finished non-slip system; the pedestrian area is made safe.

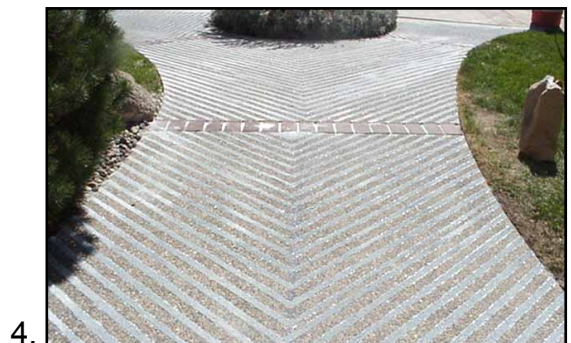
The non-slip system remains in perfect condition after several years. The potential for slippage is alleviated.
