NEW BELZONA FLOOR SURFACE FOR WORKSHOP

Engineering company in Portugal

Floors in engineering workshop containing machine tools.

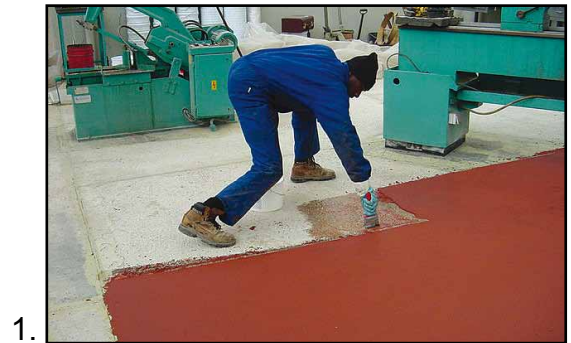
1. Belzona® 4911 (Magma TX Conditioner) being applied to ensure maximum adhesion
2. Application of Belzona® 4131 underway
3. Completed application
4. Another view of completed application
