SERVICE LIFE EXTENDED: FLYING ASH IS NO PROBLEM FOR BELZONA

Power Company in the Southwest U.S.A.

Fly ash fan moves fly ash from a lower hopper into one at an upper level of the plant.

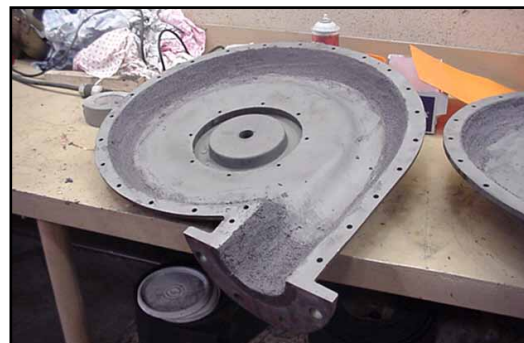
Severe wear

1. Worn fan casing damaged from abrasive particles is rebuilt and protected with Belzona® 1812.
2. Fan impeller is coated with Belzona® 2121.
3. The crew is happy with their work.

The fan impeller had a life expectancy of 3 months and costs \$1,300. The housing had a life expectancy of one year and costs \$3,000. After one year of service following the Belzona application, the fan was opened up and inspected. The impeller was 90% perfect and the housing was 100% perfect. The impeller was re-coated in June 2003, the housing remains perfect. This application has saved the customer over \$15,000 in less than two years.
