THE LIFE EXPECTANCY OF ANOTHER PUMP IS EXTENDED SIGNIFICANTLY WITH BELZONA

Coal Fired Power Plant in New Mexico,U.S.A.

March 2001

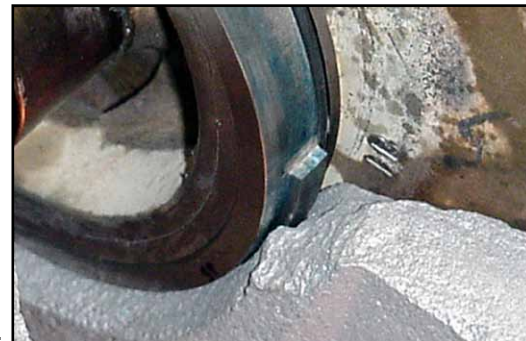
The pump was badly worn and the case ring landings were completely eroded.

1. Sever erosion of the case ring landings
2. Application in progress
3. Casing wear ring seats rebuilt
4. The pump casing is completely refurbished
