## CUSTOMER GOES NUTS OVER BELZONA FLOOR REPAIRS

Pecan Processing facility in Las Cruces, New Mexico U.S.A.

Factory Floor

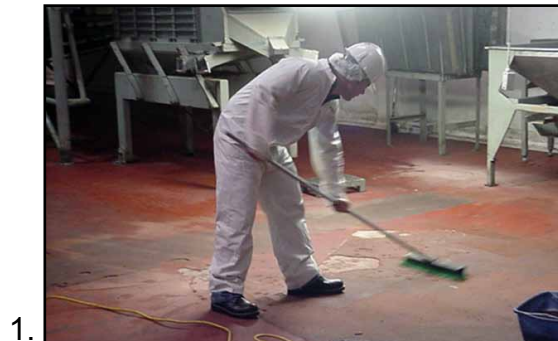
1. Cleaning.
2. Surface preparation.
3. Application.
4. Finished.

The floor was soaked with pecan oil making the application very difficult. A detergent wash was used on the floor followed by an odorless degreaser followed by mechanical abrasion. This was followed by another degreasing. The pecan factory was so pleased with these initial repairs that they purchased additional material and continue to address other floor problem areas as they arise. After several years all repairs are holding up very well.
