BELZONA CRUDE OIL TRANSFER HOSE REPAIR

Offshore Oil Company

Crude oil transfer hose.

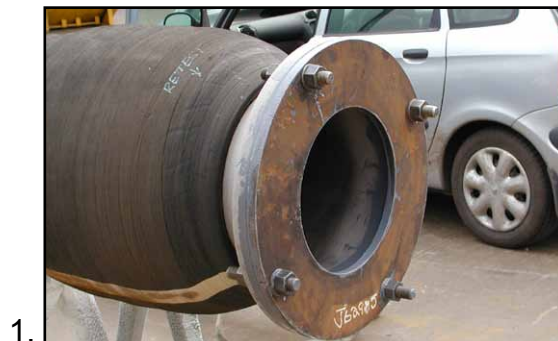
1. Former in place and tightened up.
2. The end result shows a perfectly reproduced gramophone sealing face.
3. The hose was then pressure tested to 18 bar according to International (OCIMF 1991) and Dunlop Oil & Marine Test Guidelines.

The galvanising was grit-blasted off and a new sealing face formed using the Belzona® 1321. Rubber plugs were inserted to prevent excess material seeping in to the boltholes. Metal shims were inserted to ensure an adequate thickness of Belzona® 1321 was formed on the flange face.
