BELZONA REPAIRS TO FLOATING HOSE

24" Yokohama floating hose.

Extensive damage to the rubber flotation.

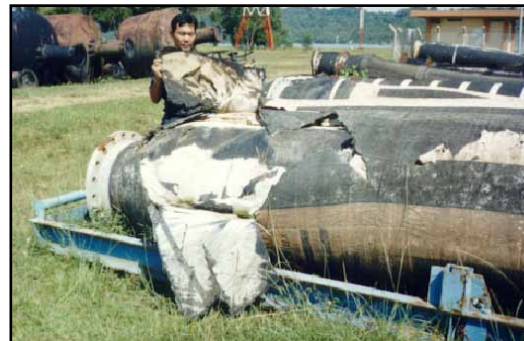
1. The extent of the damage clearly evident.
2. Application of Belzona® 2221.
3. Completed application.

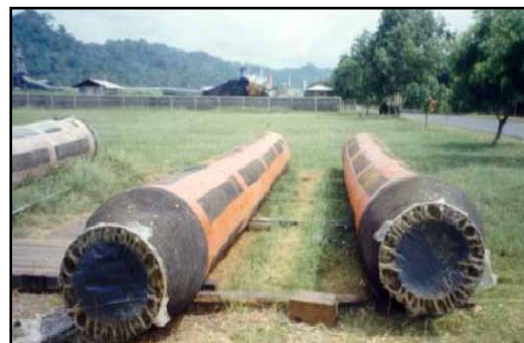
3.

Inspected February 2000 hose still in good condition. Repair cost \$3,000; new hose cost about \$70,000.
