ROUTINE REPAIR OF FLOATING HOSES WITH BELZONA

Oil transfer hoses operating between single buoy moorings and tankers.

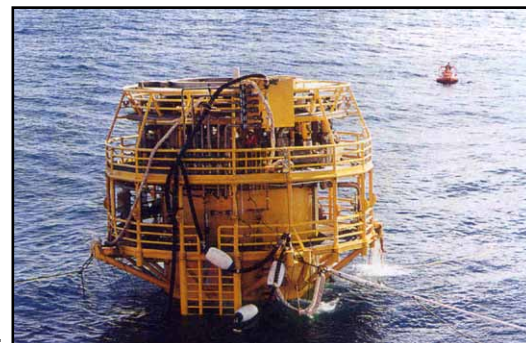
1. Typical single buoy mooring system.
2. Repaired damage to surface of the hose.
3. Completed applications.

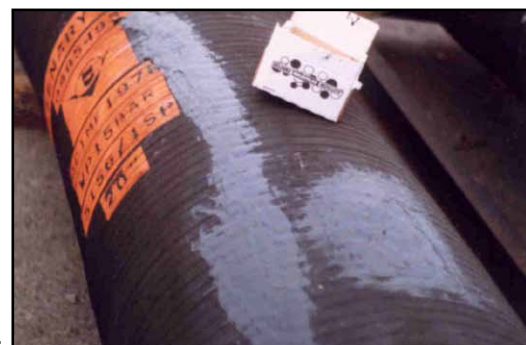
2.

Rubber coverings suffer regular mechanical damage and require refurbishment to maintain buoyancy.

Application carried out in accordance with Belzona Know-How System Leaflet SOS-12. Hoses were thoroughly cleaned, roughened and then conditioned with Belzona® 2911. The damage was then rebuilt using Belzona® 2211.
