BELZONA PROTECTION TO AERZENER LOBE COMPRESSOR

Steel Mill in Saudi Arabia

Compressors used to boost process and cool gases in the steel production process.

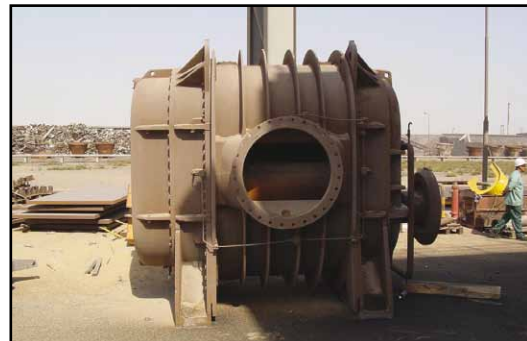
1. General view of compressor
2. Work underway on the lobe
3. Body and lobe protected with Belzona® 1391
